THIRD PARTY INSPECTION REPORT ON CPC SINGLE POINT BOUY MOORING SYSYTEM OVERHAUL- 2023

BUREAU VERITAS	INSPECTION REPORT ON SPBM 01, PERIODIC OVERHAUL –2023	Job No:
	Report No: CPC/COL/22182/IR/SPBM1	SRL.C.8.22.182

PROJECT: Third Party Inspection for Dry Docking of Crude Oil SPBM 01	CPC Agreement No: CPC/SUP/SER/04/2023
BV Client: Ceylon Petroleum Corporation, No.609, Dr. Danister De Silva Mawatha, Colombo 09, Sri Lanka.	P/O Nb. (client to BV) 4600034957 dated 22.02.2023
BV Proposal No: SRL.C.8.22.182	Service/Repair Provider: Colombo Dockyard PLC, P.O.Box 906, Colombo, Sri Lanka.

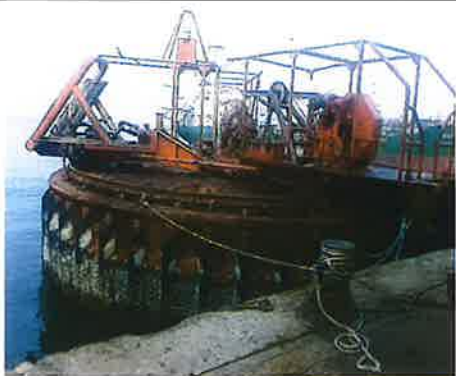
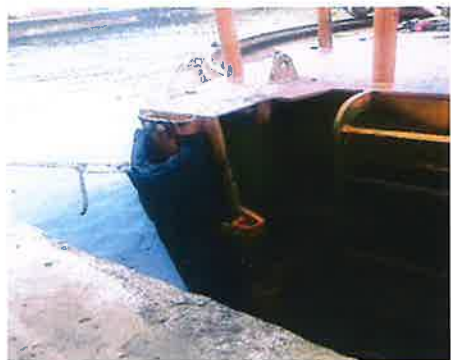
<p>P-001: Single Path - Single Point Buoy Mooring (SPBM) was brought to the Colombo Dockyard (CDL) and berthed to Dock No 3 for Overhaul.</p> <p>P-002: The Rubber Fenders were noted damaged. CPC had a plan to replace the Fenders. Accordingly they were replaced during the overhaul.</p>
30/01/2023 DIR-002

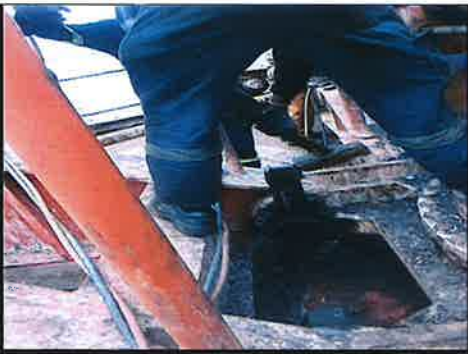
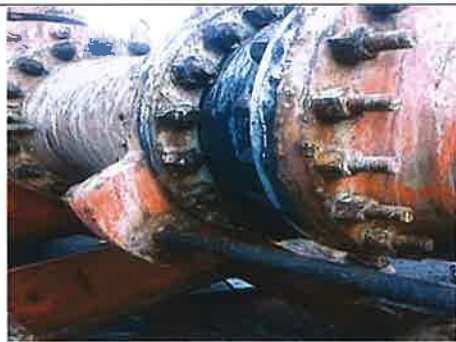
<p>P-003: The SPBM Winch Arm Pins were very tight due to insufficient lubrication (PM Program to be secured).</p> <p>P-004: Rubber Bellow and Flanges found weathered & decayed badly. Heavily corroded bolts on the 24" NPS Inlet Pipeline were flame cut for flange opening.</p>

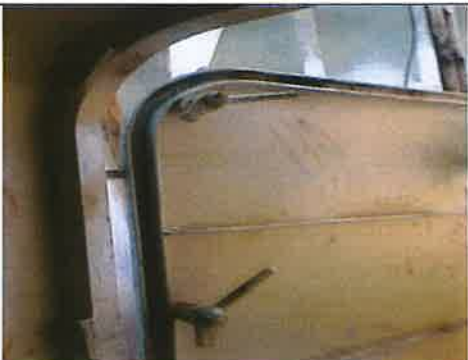
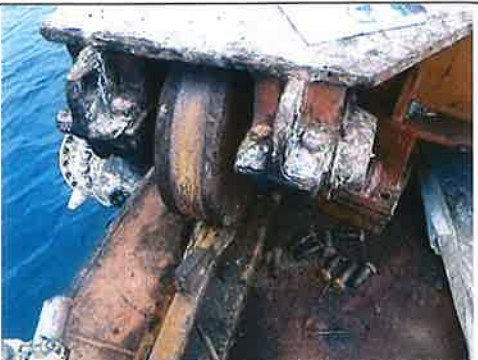
P-010: Main Watertight Door at the Buoy Entrance to PDU compartment. Deteriorated Beading was replaced. -Satisfactory.	P-011: Rotating trolley roller required Heavy Repairs. The Mounting Brackets re-bolted & painted. Rail was re-installed later.

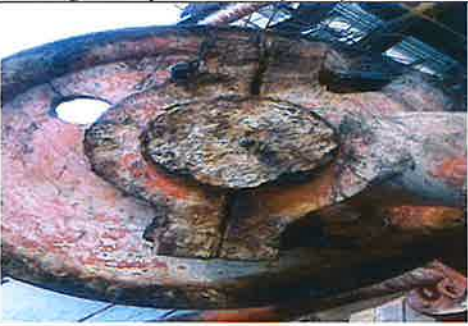
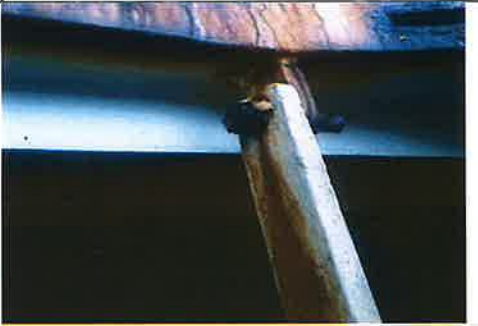
P-012: Rotating Trolley Rail Wheel Mounting bolting heavily corroded & replaced with Spring Washers. Satisfactory. Also the corroded Tugger Winch Pulley, Mounting Pin, Bracket & Bolting replaced.	P-013: The Tank Ladders revealed that heavily corroded mounting bolts. All ladders re-painted & re-bolted. Satisfactory.
02/02/2023 DIR-005 (P-014 - P-019)

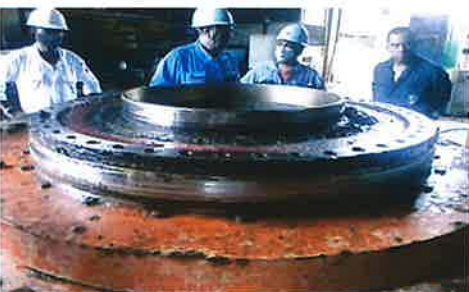
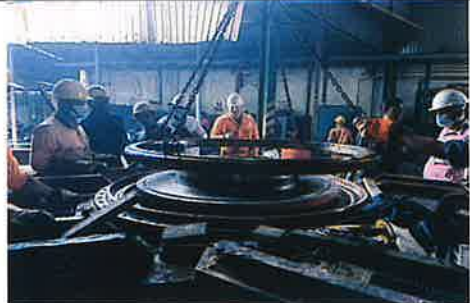
P-014: PDU dismantling and repairs were performed under OEM presence at the site.	P-015: PDU Main Bearing was dismantled after 7 Years in Operations. The decayed O' rings were replaced

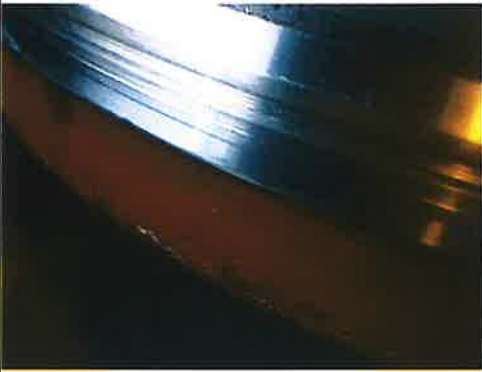
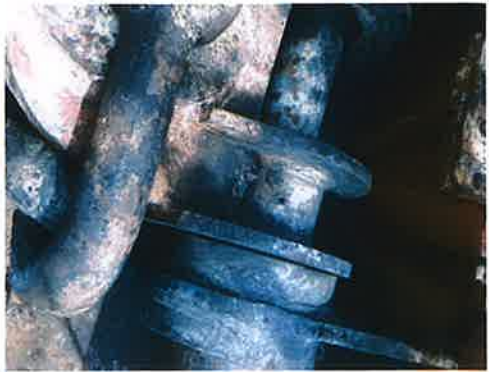
<p>P-022: PDU-Weather Seal-rubbing Surface was seriously damaged due to re-installation upset during the previous overhaul. Affected area was weld build up using a suitable compatible electrode. PT carried out & successful.</p>	<p>P-023: Bearing lubricating paths of Mooring Arm Eye was heavily blocked. Cleared and Re-inspected before Unit Assembly.</p>

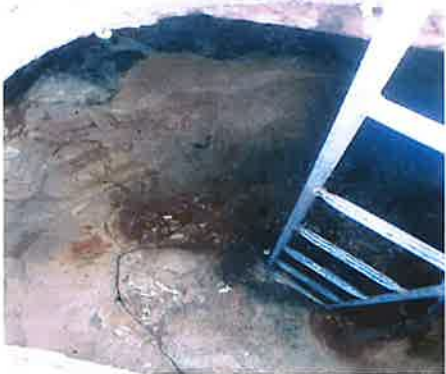
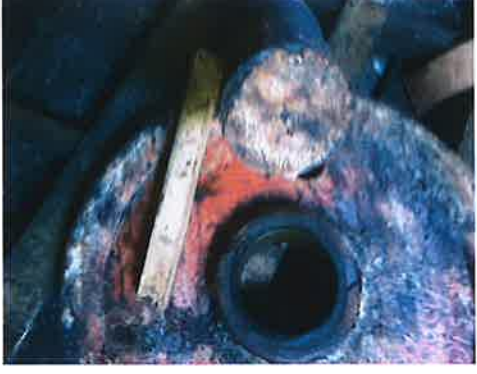
<p>P-024: Design intent for Foam Filled Tanks is to keep the SPBM Floating even during a Tank Perforation (for Safe Self Buoyancy). This Foam was removed to allow Welding Repairs (Potential Fire). The removed Foam was not replaced before recommissioning. Need change documentation with an approved Management of Change (MOC).</p>	<p>P-025: Winch cable running pulley pin observed with galling due to insufficient lubricant.</p>

Client removed Flotation Foam filled inside the SPBM Buoyancy Compartments. This is to allow hot work (welding) in the proximity due to fire-risk. At the end of the repairs, the Client did not replace the removed foam, with the consent of the on-site OEM representative as well as OEM’s technical advice since foam is no longer use in their design.

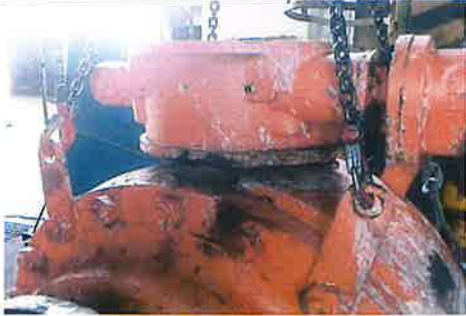
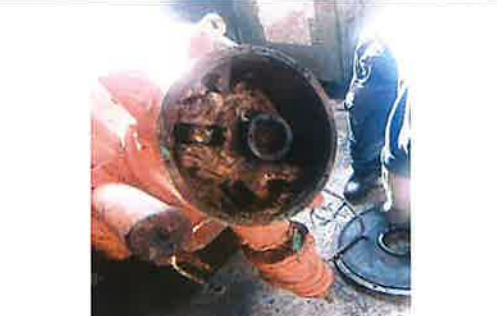
<p>P-032: Main Ball Valve Actuator being Dismantled.</p>	<p>P-033: Main Valve Actuator Internal Deposits due to potential Sea-water Ingress. Actuator cup thinned down due to Under-deposits-Corrosion.</p>

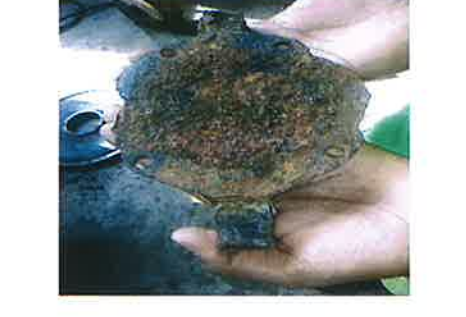
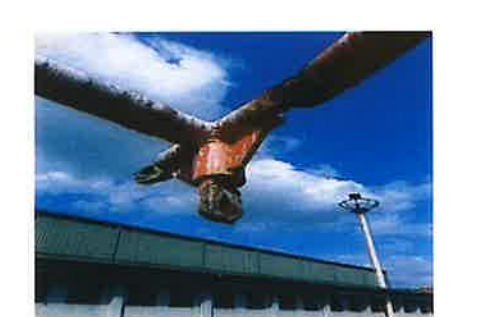
<p>P-034: Mooring Arm Deck Timber Floor showed Deterioration.</p>	<p>P-035: Rotating Arm Antifouling Structure – Corroded Bolts replaced in-kind.</p>

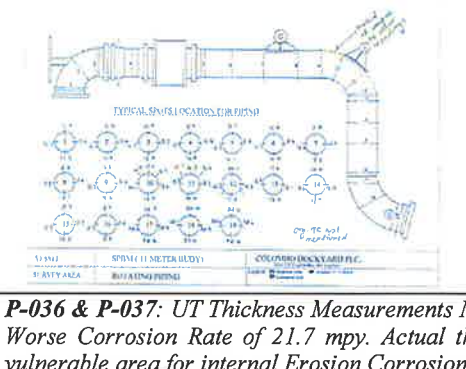
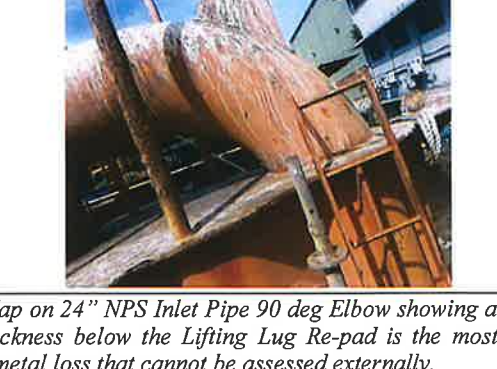
<p>P-036 & P-037: UT Thickness Measurements Map on 24" NPS Inlet Pipe 90 deg Elbow showing a Worse Corrosion Rate of 21.7 mpy. Actual thickness below the Lifting Lug Re-pad is the most vulnerable area for internal Erosion Corrosion metal loss that cannot be assessed externally.</p>

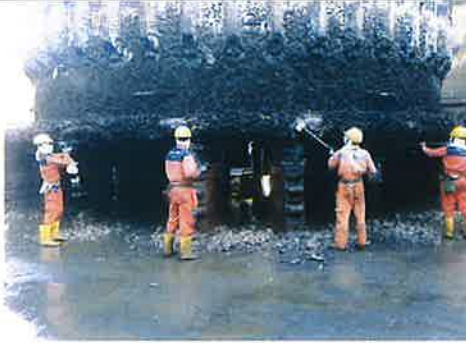
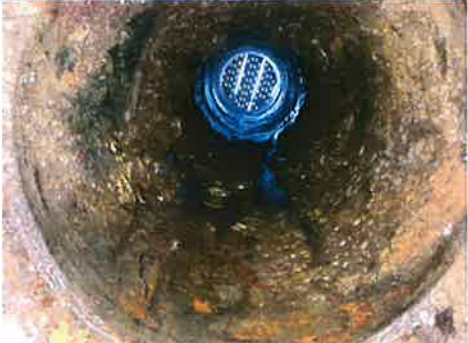
<p>P-038: SPBM at Doc # 4. The Hull and Bottom showed usual Marine Growth as expected. Algae, Aquatic Weeds, or Marine Invertebrates such as Asian Clams, Zebra Mussels, and other small organisms. Marine growth was removed by mechanical scraping. Usual Anti-fouling Technique is applying an effective marine grade coating System.</p>	<p>P-039: Anchor Hawse Pipe after Cleaning of Marine Growth. Reasonably in good Integrity. There are Six (6) Anchor Hawse Pipes for handling the SPBM Anchors. They are open to Sea Water. BV noted deep isolated corrosion pits on the Anchor Hawse Pipe ID.</p>

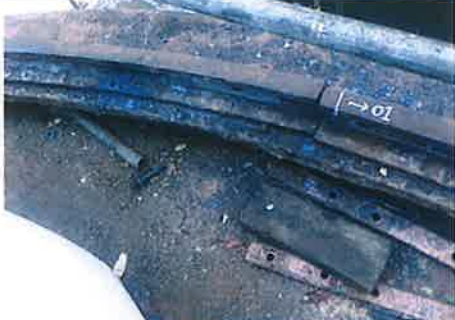
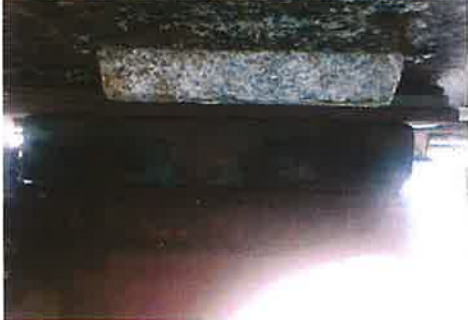
<p>P-040: Rail and rail bed on the SPBM Deck were heavily corroded. Total Station Survey showed unacceptable Rail Bed Levels. Corroded and deformed rail and rail-bed were satisfactorily refurbished.</p>	<p>P-041: Extremely good CP installation; 29 Nos Zinc Sacrificial Anodes (20 kg Each) almost Consumed (> 95%) except for one Zinc Anode. It may be inactive possibly due to improper installation thus allowing Marine Growth to isolate the Anode and Hull. Anodes were mounted on board with M-16 SS 316 Bolt with Nut and lock Washer.</p>

- a. **Worn-out Teflon pads** – Plan to replace the worn-out PTFE Pads.
- b. **Rail Mounting Bed** – Plan replacing the Rail Mounting Bed which is heavily and irregularly Corroded.
- c. **SPBM Deck** – Plant mechanical insert-plate type repairs and re-coating of the Buoy Deck Topside. Strongly recommended high thick, abrasion resistant marine grade coating system to re-coat the entire deck after blast-cleaning.
- d. **Tugger Winch Pulley-** This was touching a Pipeline and it was corrected by re-aligning the Pipe Layout. This was a temporary repair with CDL adjustment related to this potential Abrasion Damage. Plan to rectify this situation as per 2028 observations.
- e. Plan to replace the **Toolbox on Pipe Arm**. Clean and offer for re-inspection of all Grease Paths for Arm Lubricating System.
- f. Plan to replace all **PDU Seals (O’ Rings)** to be replaced.

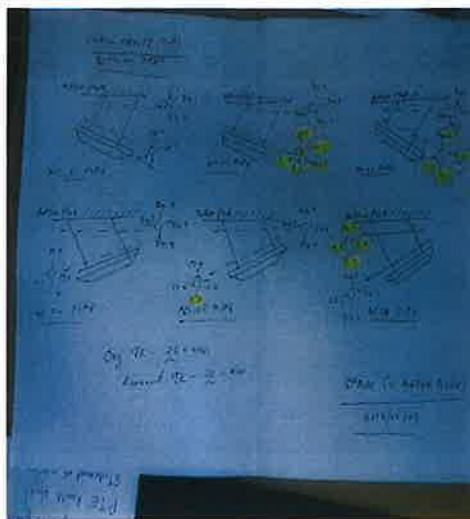
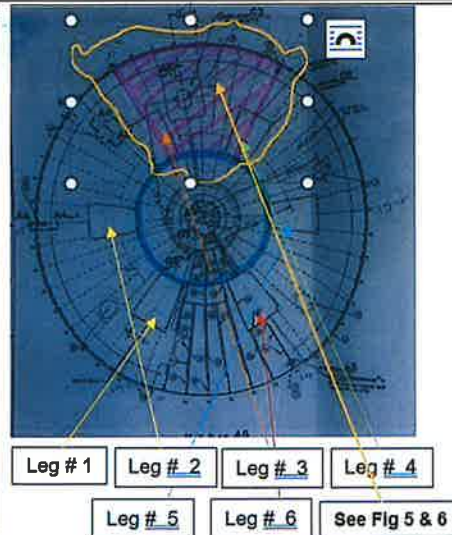
P-042 & P-043: Anchor Hawse Pipes UT Thickness Measurements showed relatively heavy general metal loss (From 25 mm original thickness to 11-12 mm metal loss where minimum required thickness specified is 20mm) due to Anchor Chain **Abrasion** Assisted Corrosion Metal Loss. The Leg # 2 Anchor Hawse pipe has **perforated** near the outlet mouth while the remaining wall measured even 3.2 mm around the corrosion-hole. Noticeably, the Leg # 6 Hawse Pipe thinning was confined to the area near the Buoy Exit, unlike the rest shown as at Pipe Exit. In summary, the minimum-measured thickness of other Anchor Hawse Pipes are: Leg # 1 (16.1 mm), Leg # 3 (13.4mm), Leg # 4 (16.9 mm), Leg # 5 (11.3mm) and Leg # 6 (11.2mm) out of original thickness of 25 mm.

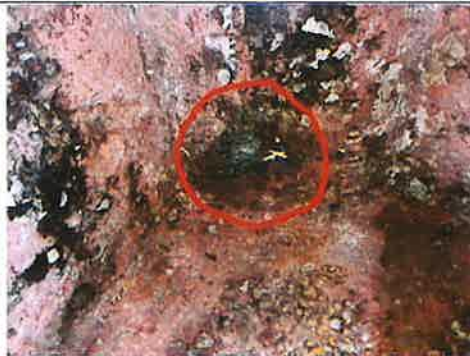
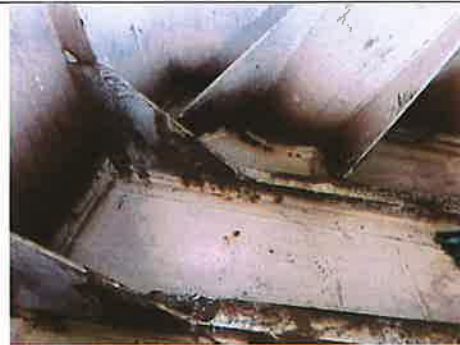
P-044: Internal Corrosion Hole was noted on Leg # 2 Anchor Hawse Pipe Outlet Mouth. The 25 mm original thickness showed readings around 3.2 mm. Only Leg # 6 Anchor Hawse ID showed relative thinning by Buoy Exit. There are 6 Anchor Hawse Pipes.

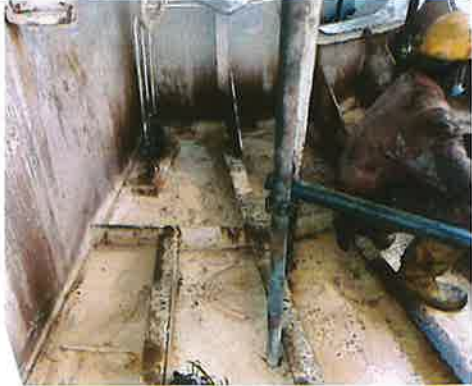
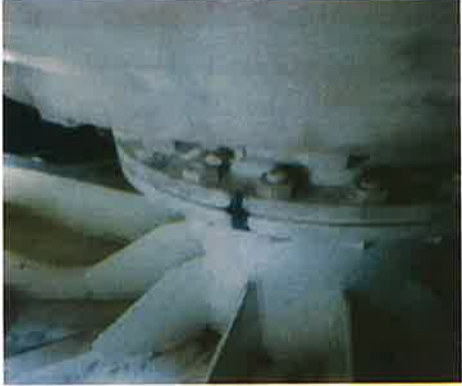
<p>P-046: Tank Interior between Leg # 3 & Leg # 4 showed localized initial rusting & required Spot Priming and Overcoating.</p>	<p>P-047: Protective Coating in the Centre Tank Internal Surface showed no signs of significant damages.</p>

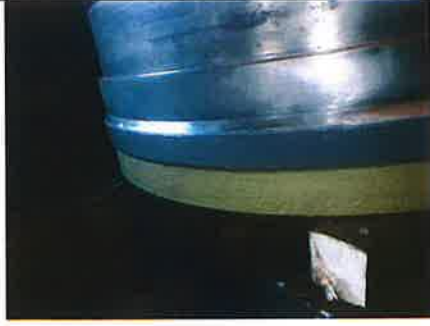
<p>P-050: Total 15 nos Rubber Fenders were found Chain Hardened and Brittle. Free radicals produced by heat, oxygen and light combine to form new crosslinks, which reduces flexibility and leads to hardening</p>	<p>P-051: Flexible Joint in the PDU Unit (Suspected SS 316) noted for > 1mm deep wear-out against rubbing of Weather-shield. CDL attempted applying Devcon which failed during machining. Finally weld-overlaid with compatible electrodes & machined successfully.</p>

- 4.3.1 **Rubber Fenders & Rubber Bellows**– Have in hand 15 nos Neoprene or NBR Rubber Fenders and set of Rubber Bellows.
- 4.3.2 All OEM Spares for **PDU Seals**.
- 4.3.3 **Worn-out Teflon pads** – Have in hand, replacement Teflon (PTFE) pads.
- 4.3.4 **Cable of Chain Tension Winch** with the Thimble End.
- 4.3.5 Replacement **Toolbox on Pipe Arm**.
- 4.3.6 All **PDU (O' Rings) -OEM** Spares.
- 4.3.7 Replace the corroded (marked) **Bolts of Tension Winch Bolts**, other Bolting Materials (Studs and Nuts in-kind).
- 4.3.8 Have a set of **20kg Zinc Anode Blocks** in hand (30 nos).
- 4.3.9 **Fender brackets for Balance Arm**.

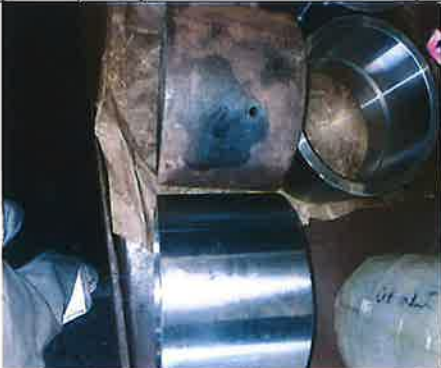
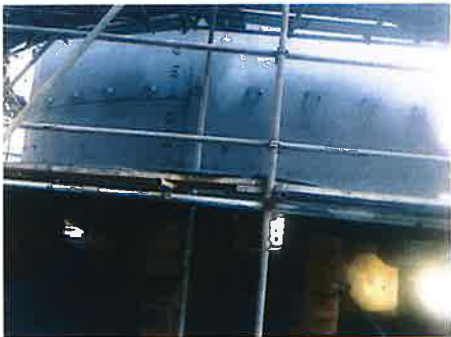
P-055: No Grease Hole for New Arm Bushes. Drilled new holes and rectified. Satisfactory.	P-056: No Grease Hole for New Arm Bushes. Drilled new holes and rectified. Satisfactory	
12/02/2023 DIR-014 (P-057 - P-060)

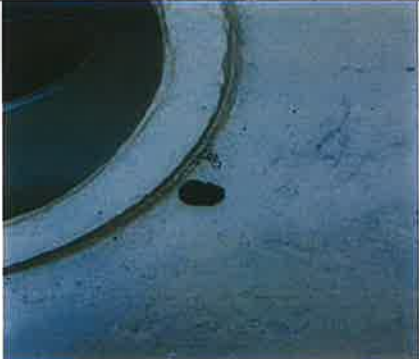
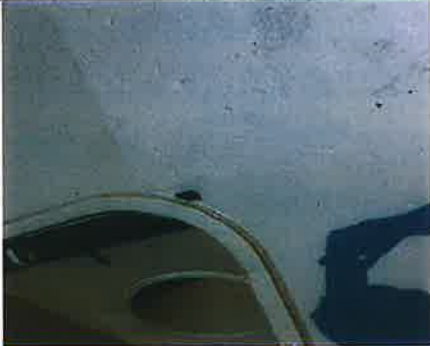
P-057 & P-058: Corrosion Holes near Leg #2 & Leg #4 Anchor Pockets. Topside Corrosion. Areas were replaced with insert plates.

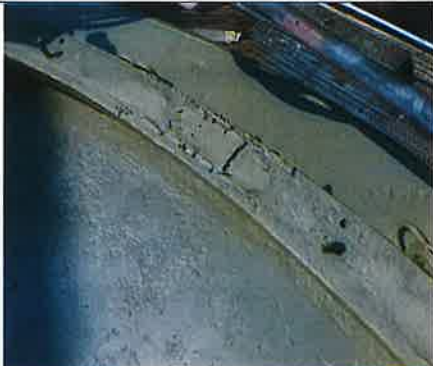
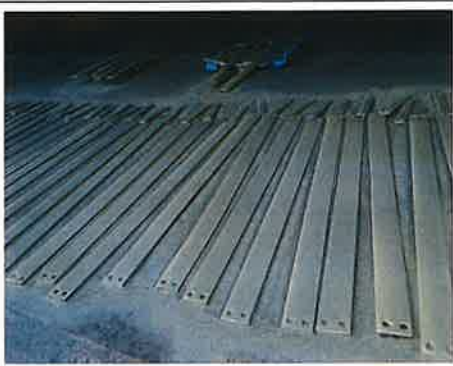
<p>P-059: The SPBM Deck Rail Mounting Bed was thinned down and patch repaired with SS 316 Strips. Visual inspection revealed no considerable deck deformation.</p>	<p>P-060: Rubber Fender Mounting Strips (SS 316) in satisfactory condition. The chain hardened Neoprene Fenders were replaced.</p>
13/02/2023 DIR -015 (P-061 - P-066)

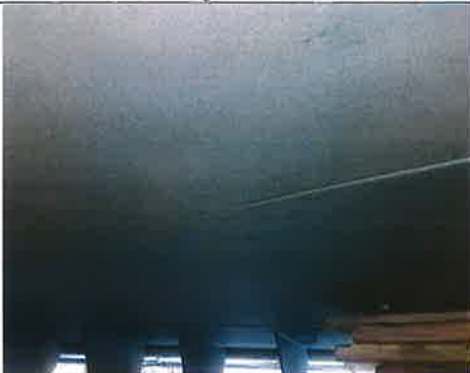
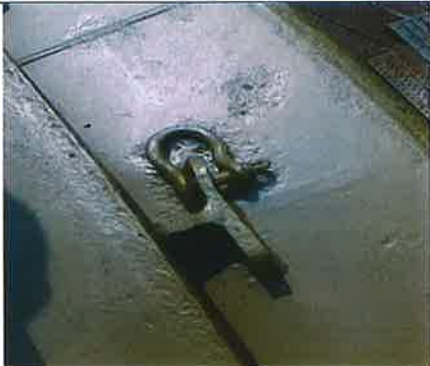
<p>P-061: Buoy Bottom & Hull OD showed successful CP Activity. Only 1/30 Zinc Anodes (20kg each) showed Zero Activity. Rest showed more than 95% Decay.</p>	<p>P-062: The Area Around Small Boat Mooring Cleat was found Heavily Pitted. Some of them were found distorted noticeably.</p>

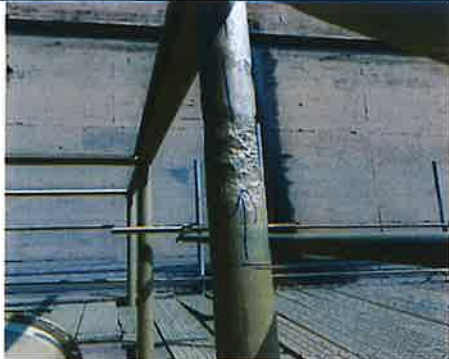
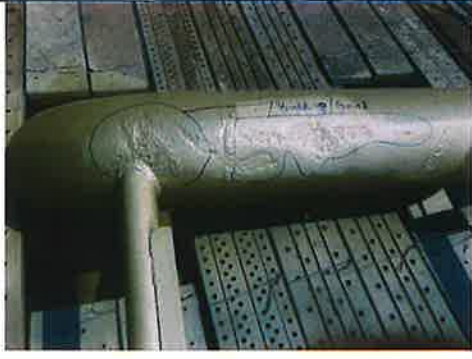
<p>P-065 & P-066: - Deep Localized External Corrosion on the piping associated with Antifouling Structure of Arms. Root-cause is unknown. Operators to stay vigilant. Weld repaired and OK.</p>
14/02/2024 DIR-16 (P-067- P-068)

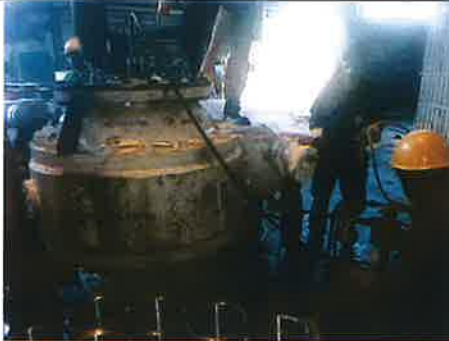
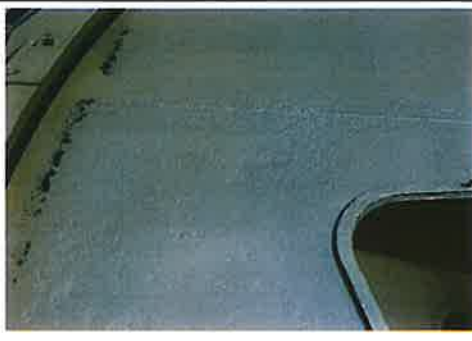
<p>P-067: BV Witnessed the Centre Chamber Valve Pressure-test @ 15 barg and found satisfactory.</p> <p>P-068: Perforations in the SPBM main deck due to topside under-deposit-corrosion.</p>
15/2/2023 DIR -017 (P-069- P-074)

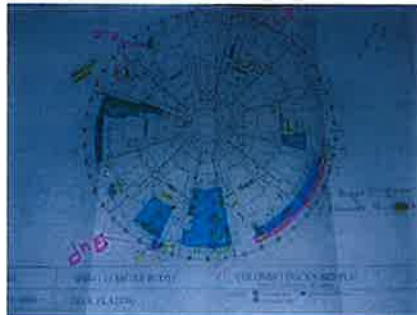
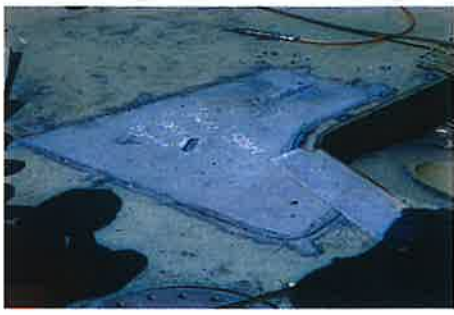
<p>P-069: BV reviewed UT Thickness Report on SPBM Deck and marked replacement location as, Blue for Insert Plates & Red for Reinforcing.</p> <p>P-070: CDL utilized plate material equivalent to ABS Grade A for Insert Plates. Used Doubler plates for Reinforcing requirements.</p>

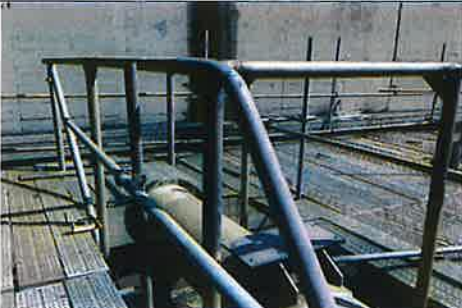
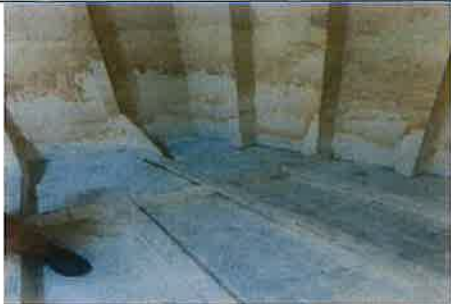
P-075: Corroded Antifouling structure mechanical repair. To be painted later.		P-076: SPBM tanks (3/6) after removal of foam revealed mechanical scratch marks. Coating damages were patch repaired.

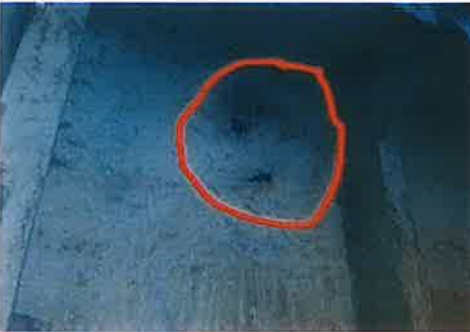
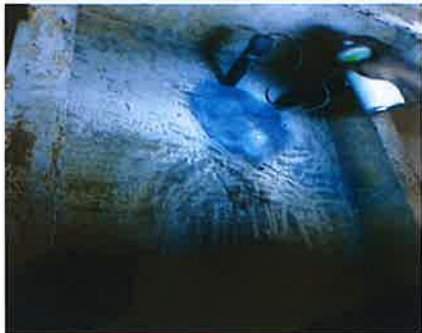
P-077 & P-078: BV observed two (2) Hull Dents between Leg 2 / Leg 3 and Leg 4/ Leg 5. The areas were examined for surface cracks utilizing Magnetic Particle Testing. MT reported no relevant indications. Shown above is the locations concerned between Leg# 2/Leg #3.			
17/02/2023 DIR -019 (P-079- P-082)

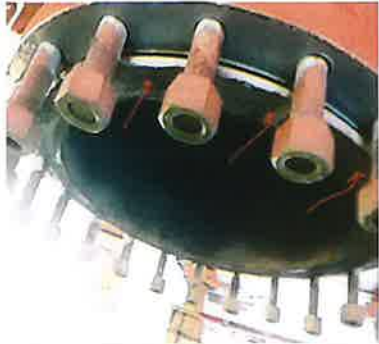
<p>P-092: The pipe flange under the Buoy revealed several gasket-face damages some > 1/3rd of the face-width. In situ machining was performed and rectified the situation.</p>	<p>P-093: DFT was verified for OEM compliance on the Antifouling Coating Sigma-cover 555 at bottom of SPBM. Satisfactory.</p>
21/02/2023 DIR -023 (P-094- P-099)

2.7 In-situ Machining Facility for Damaged Gasket Faces was a proven advantage during this SPBM Overhaul too. Leaks from the flanged gasket joints may cause Oil Spills and related environmental pollution. The flange under the Buoy was successfully machined (in-situ) and rectified for radial damages more than 1/3rd Serration width. This is highlighted as a strength from the CPC maintenance capabilities.

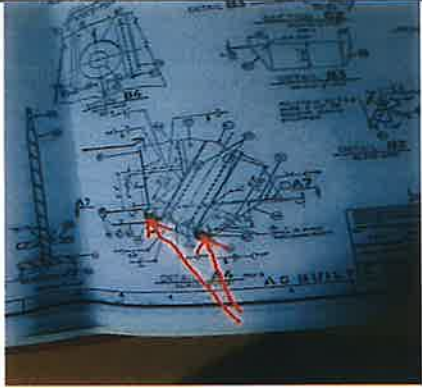
<p>P-094: Shown with RED Arrows above is the Half Tubular Circular Section welded to the Anchor-Hawse Outlet Periphery as a Belmouth Opening aimed at minimizing potential rubbing and subsequent abrasion damage to the Anchor Hawse Nozzle Opening by the Anchoring Chains due to continued Sea Wave Surges as well as Tidal (High and Low) Transitions. One of the Belmouth Half Tubular Section showed signs of Water Ingress and corroding the Tube Wall internally (Crevice Corrosion). Water was dripping from a hole.</p>

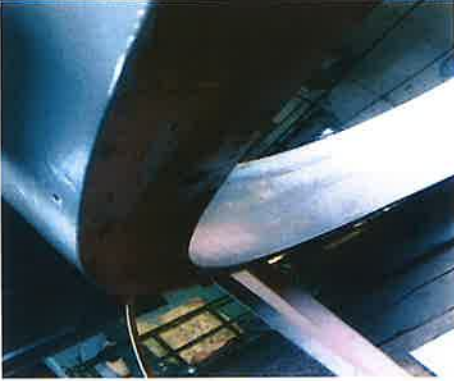
<p>P-095: PDU Turning Bed Bottom Face showing dry adherent Paint Scales and Rust Deposits. Cleaned with Mechanical and Emery Paper Cleaning and ensured a smooth flat Profile.</p>

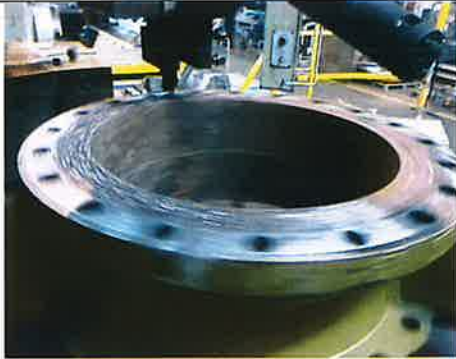
<p>P-096 & P-097: Both flanged Inlet & outlet (24") pipe spools required gasket face dressing (In-situ Machining) due to both mechanical scratches and shallow corrosion pitting.</p>

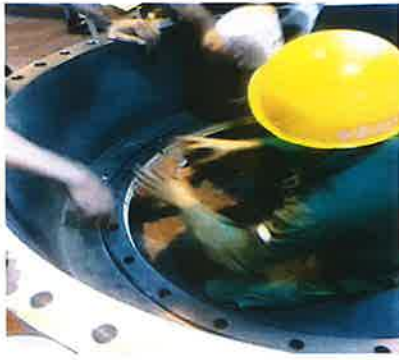
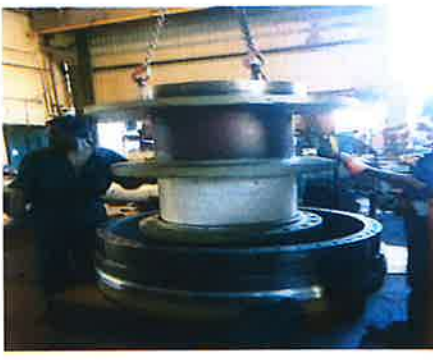
<p>P-098: PDU Item # 2 Re-assembly required a new O'-Ring (OEM Supplied) beneath the Fixing Ring. The O' Ring occupies the Space outside the Fixing Ring Bolt Circle Outer Circumference.</p>	<p>P-099: PDU re-assembly was witnessed by BV with OEM and ensured compliance to the assembly drawing and OEM instructions.</p>
22/02/2023 DIR -024 (P-100- P-101)

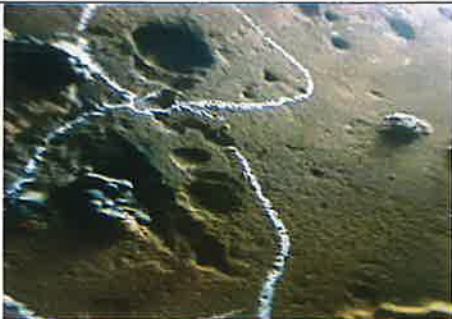
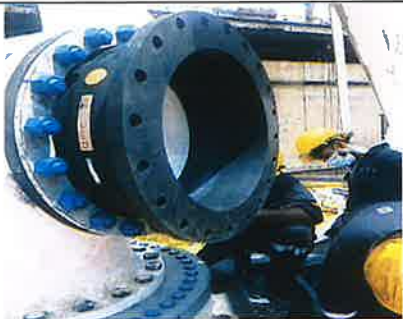
<p><i>P-123: Re inspection revealed deep lake type irregular corrosion pits in the Leg # 2 Anchor Hawse Pipe internal surface. Weld repaired satisfactorily, as per BV recommendations.</i></p>	<p><i>P-124: New Neoprene Rubber Bellows with new bolting materials. Replaced in-kind.</i></p>	
28/2/2023 DIR-030 (P-125- P-130)

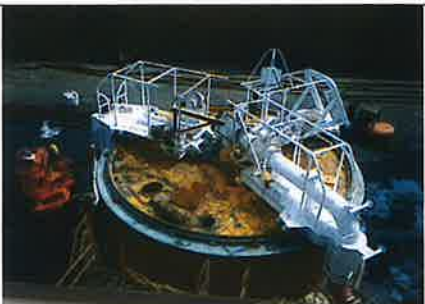
P-131: The Tugger Winch Ready to return to Buoy after Servicing & Oiling & Lubrication).	P-132: Three (3) Arms, Pipe Arm, Mooring Arm and Balancing Arm, were Tested for Rotationality. BV Witnessed & accepted the tests.
02/03/2023 DIR – 032 (P-133- P-138)

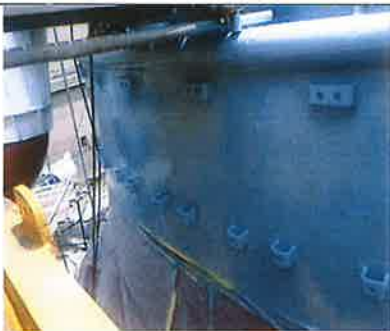
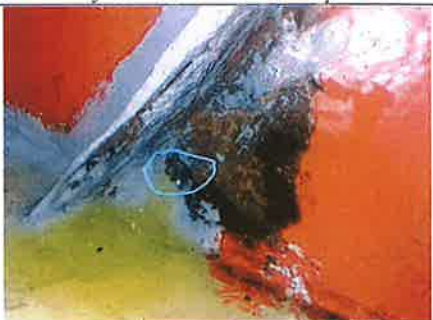
P-133: SIGMASHIELD™ PRIME -Gray with 65% Volume Solids x 250 microns for Cargo External Exposure. Note the Fender Mounting Clips with required integrity.	P-134: The Tugger Winch Gear Oil Reservoir showed a Leaking Pin-hole due to External Under Deposit Corrosion.

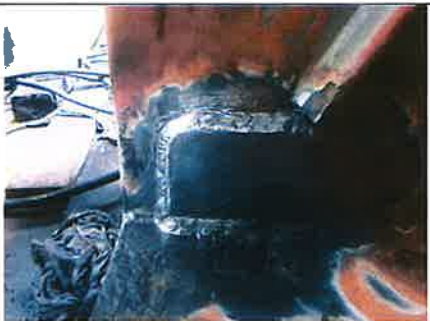
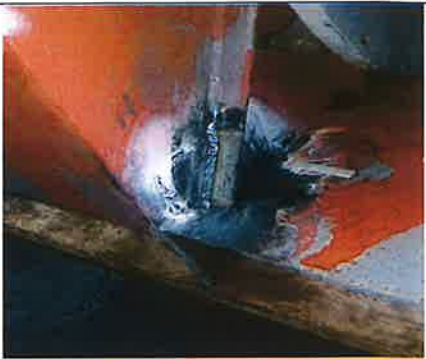
P-135: BV recommended a lap welded 10mm thick doubler pad.	P-136: Further replaced the knife-edged Radial Reinforcing Flat Bar as well. Flat Iron using 8.0 mm Plate Section was used. PT Results satisfactory.

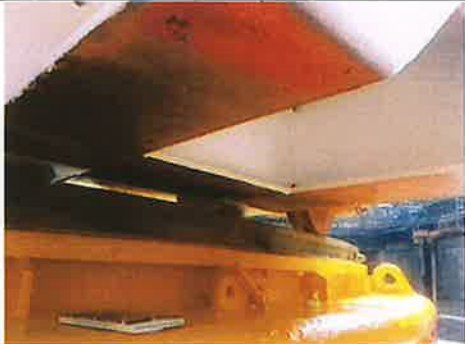
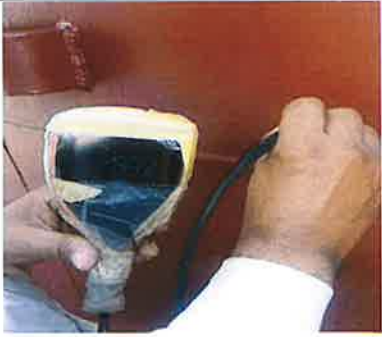
P-139: Some area of Mooring Arm underside was not painted. Revealed during final Punch listing.	P-140: Side wall below load water line DFT was found more than 830 microns

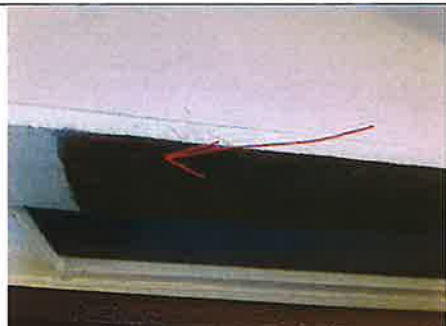
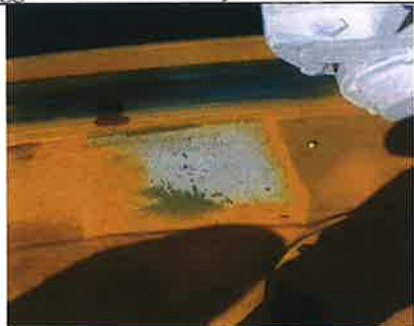
P-151: Some areas under the Balancing arm found without painting. Final Punch listing. Area was painted.	P-152: Some areas on the Deck were found without painting. Final Punch listing. Area was painted.

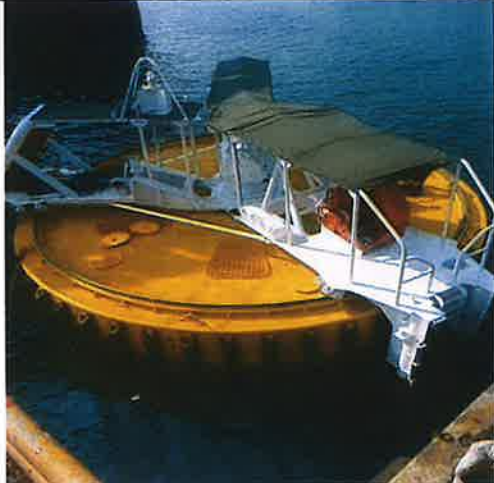
<p>P-155: The SPBM Integrity is assured for Safe, Reliable and Uninterrupted Operation for another five (5) Years provided that an Effective Preventive Maintenance (PM) Program is in place and monitored closely. PM Program shall include:</p> <ul style="list-style-type: none"> a. Operating Maintenance Checks at least every 6-Month intervals. b. Maintain the Lubrication Process for PDU, Arms Mounting Pins, Mooring beams c. Perform periodic Diver Inspections to confirm Active Decay of Zinc Anodes. Rectify any inactive Anodes. f. Include inspections on Anchor Hawse Pipes for bad corrosion damages.
