THIRD PARTY INSPECTION REPORT ON CPC SINGLE POINT BOUY MOORING SYSYTEM OVERHAUL- 2023

BUREAU VERITAS	INSPECTION REPORT ON SPBM 01, PERIODIC OVERHAUL –2023	Job No:
	Report No: CPC/COL/22182/IR/SPBM1	SRL.C.8.22.182

PROJECT: Third Party Inspection for Dry Docking of Crude Oil SPBM 01	CPC Agreement No: CPC/SUP/SER/04/2023
BV Client: Ceylon Petroleum Corporation, No.609, Dr. Danister De Silva Mawatha, Colombo 09, Sri Lanka.	P/O Nb. (client to BV) 4600034957 dated 22.02.2023
BV Proposal No: SRL.C.8.22.182	Service/Repair Provider: Colombo Dockyard PLC, P.O.Box 906, Colombo, Sri Lanka.

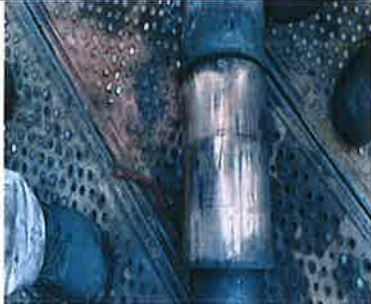
<i>P-026: Mooring Arm Bush almost galling due to insufficient lubrication.</i>	<i>P-027: Mooring Beam Pin was difficult to remove due to lack of lubrication.</i>

4.1.5 **Lubrication** – This is a Key PM Element and there were ample lessons learned during the 2023-SPBM Overhaul due to inadequate or ineffective in-service lubrication procedures and supervision. The Winch Arm Pins were found galling due to poor in-service lubrication. Almost Seizures were observed with the Pipe Arm Pins. Besides, many blocked or restricted lubricant paths were noted while the used lubricants were rated sub-standard, and frequency of refreshing the lubricants seemed inadequate.

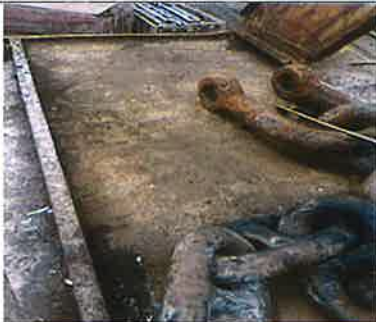
<i>P-028: Mooring Arm Deck Timber Sheathing Floor with corroded angle irons.</i>	<i>P-029: Corroded Mooring Arm Fire Leak Bracket was found heavily thinned & replaced.</i>

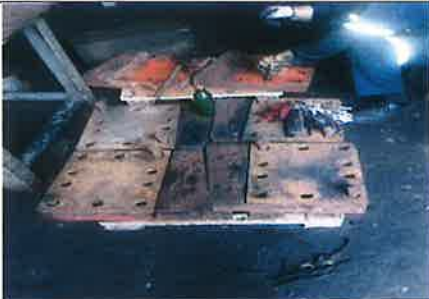
<i>P-030: Rotating arms Teflon Pads</i>	<i>P-031: SPBM shifted to Dock No 4.</i>

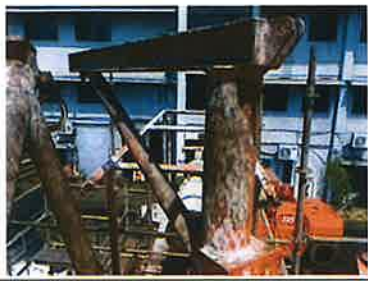
<p>P-048: SPBM Deck Lifting Davit was found externally corroded, but the davit is in good integrity. Repainted successfully.</p>	<p>P-049: The Teflon pads placed in Mooring/ Balancing/Piping Arm, revealed significant wear. Worn pads were replaced in-kind.</p>

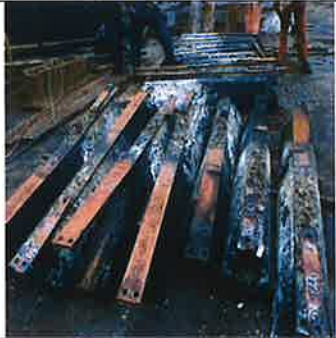
<p>P-050: Total 15 nos Rubber Fenders were found Chain Hardened and Brittle. Free radicals produced by heat, oxygen and light combine to form new crosslinks, which reduces flexibility and leads to hardening</p>	<p>P-051: Flexible Joint in the PDU Unit (Suspected SS 316) noted for > 1mm deep wear-out against rubbing of Weather-shield. CDL attempted applying Devcon which failed during machining. Finally weld-overlaid with compatible electrodes & machined successfully.</p>

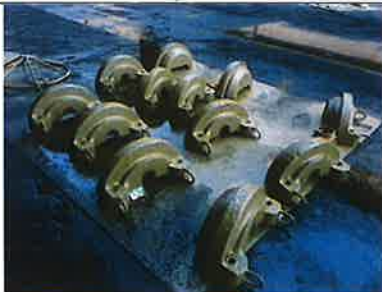
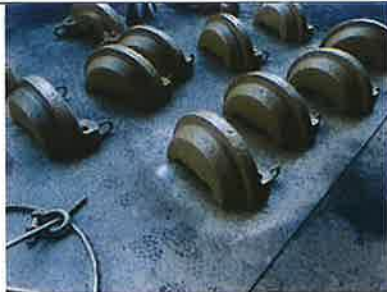
<p>P-063 & P-064: Both front side and backside of Chain Stoppers were found intact.</p>

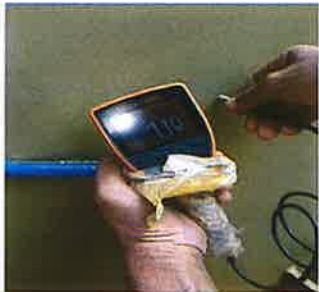
<p>P-083: Coating thickness measured on the Hull underwater area. DFT was above OEM recommendations.</p>	<p>P-084: Anchor Hawse Pipe was weld built up. Corrosion pits could not be repaired due to limited access were filled with a marine filler.</p>	<p>P-085: Visual inspection was done to weld built up area of PDU item No 2 and BV observed that repaired area was in satisfactory condition.</p>
19/2/2023 DIR -021 (P-086- P-089)

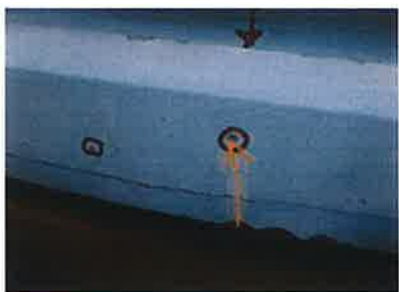
<p>P-090: PT performed on PDU Item no 2, weld built up area showed 2 Porosities. Rectified same time.</p>	<p>P-091: Leg # 3 Anchor Hawse Pipe Flanged End - Doubler Plate installed. near the flange.</p>

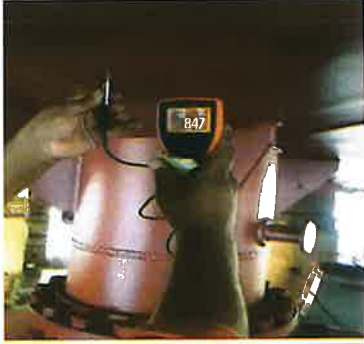
<p>P-092: The pipe flange under the Buoy revealed several gasket-face damages some > 1/3rd of the face-width. In situ machining was performed and rectified the situation.</p>	<p>P-093: DFT was verified for OEM compliance on the Antifouling Coating Sigma-cover 555 at bottom of SPBM. Satisfactory.</p>
21/02/2023 DIR -023 (P-094- P-099)

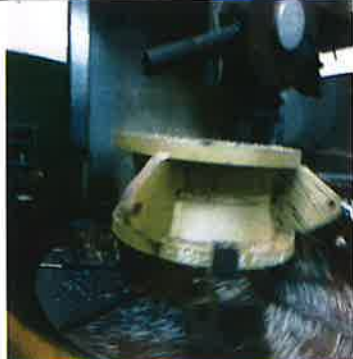
<p>P-096 & P-097: Both flanged Inlet & outlet (24") pipe spools required gasket face dressing (In-situ Machining) due to both mechanical scratches and shallow corrosion pitting.</p>

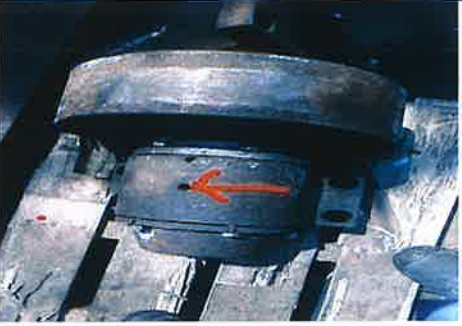
<i>P-102: Wheel Buggy Set – An Overview</i>	<i>P-103: Lubrication Path was blocked and required clearing.</i>

- f. **Ensure Periodic PM Activity for Boggy Wheels** Lubrication System aimed at regular de-blocking of the Lubrication Paths.
- g. **Battery Box** - Proposed to use anti-seizure compound (Copper slip) while tightening bolts to provide joint protection from heat and corrosion. Recommend keeping Battery box lid in closed position every time to avoid seawater ingress.

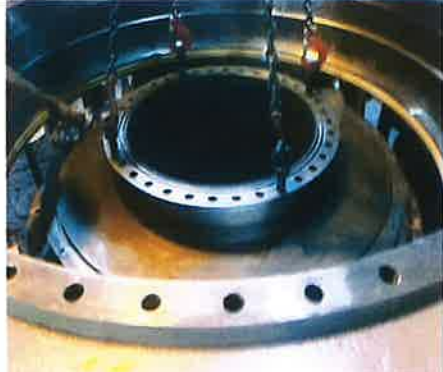
<i>P-104: Weather Shield being re-installed. This is the item that was not installed properly in 2015 and eventually abraded the PDU Item # 2 which had to be weld-overlaid and machined during 2023 overhaul.</i>	<i>P-105: PDU after Weather Shield was re-installed properly. OEM and BV both on-site with the Client, CPC.</i>
	<i>P-106 & P-107: Mooring Arm Painting. Some Coating Holidays marked and rectified. DFT Measurements reviewed and in compliance.</i>

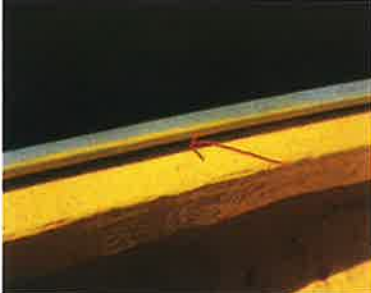
2.8 Rotary Laser Level Technique (By SkyTech Laser Technologies) was utilized for checking the Rail Mounting Bed flatness. The subject Rail and the Rail Bed were found with heavy and Irregular corrosion damage. CPC approach to use the Laser Leveling technique to rectify the situation is recognized as a good practice. BV Recommends Verifying the Final Placement also with a repeated Laser Scan. It was not verified in 2023 Overhaul.

P-119: Gaps between Rail and Rail Resting Beam, between leg 5 & Leg 6. Noted is that recommended confirmation Laser Survey was not performed after repairs.	P-120: PDU is placing at the centre of SPBM.

- a. **Worn-out Teflon pads** – Plan to replace the worn-out PTFE Pads.
- b. **Rail Mounting Bed** – Plan replacing the Rail Mounting Bed which is heavily and irregularly Corroded.
- c. **SPBM Deck** – Plant mechanical insert-plate type repairs and re-coating of the Buoy Deck Topside. Strongly recommended high thick, abrasion resistant marine grade coating system to re-coat the entire deck after blast-cleaning.
- d. **Tugger Winch Pulley-** This was touching a Pipeline and it was corrected by re-aligning the Pipe Layout. This was a temporary repair with CDL adjustment related to this potential Abrasion Damage. Plan to rectify this situation as per 2028 observations.
- e. Plan to replace the **Toolbox on Pipe Arm**. Clean and offer for re-inspection of all Grease Paths for Arm Lubricating System.
- f. Plan to replace all **PDU Seals (O’ Rings)** to be replaced.

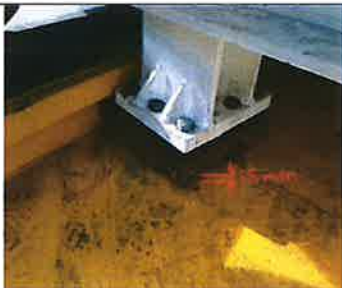
P-129: Teflon Pad Assembly Fixed on Arms Showed a 15mm Gap between the Pad & Deck.	P-130: New Rubber Fenders. No MTC available, no stamp, no evidence for Neoprene Rubber. Replaced as old Fenders are Chain Hardened.
01/03/2023 DIR - 031 (P-131- P-132)

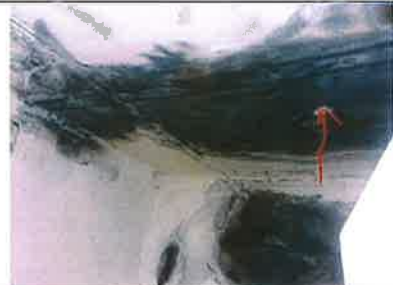
DIR – 033 03/03/2023 (P-139- P-138)	P-137: Blistered & detached Coating Damages due to poor application techniques or environmental conditions.	P-138: Power Tooled Substrate was Satisfactory (St-2- Finish).

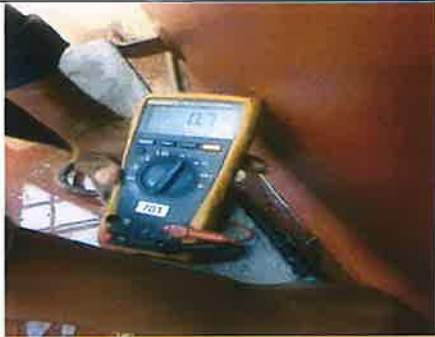
P-141: Hull Bottom Anode Continuity Testing (Anode = Zinc w/20kg Weight (24"x4"x4" Volume). Satisfactorily conductive.	P-142: Rubber Fender Installation.
05/03/2023 DIR – 035 (P-145- P-146)

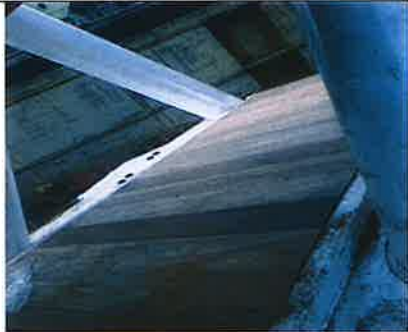
P-143: Mooring Arm Deck-timber Sheathing	P-144: Top View of Assembled Arms (Pipe, Balancing & Mooring Arms).

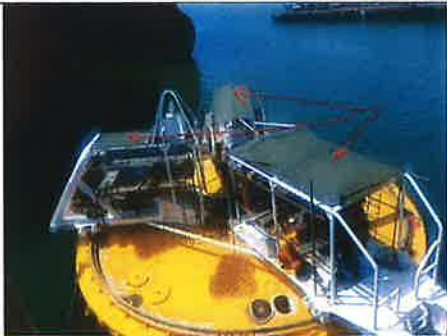
P-145: Canvas Roof Installed- Satisfactory.	P-146: Manhole Covers Seating Confirmed Satisfactory with Chalk Test.

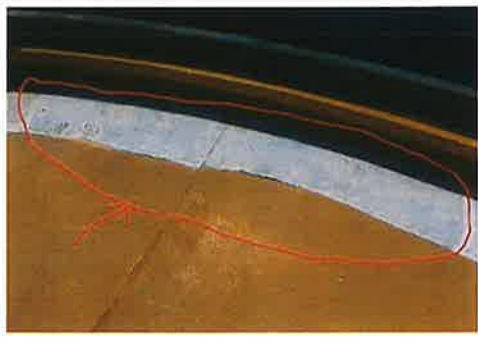
P-147: Sigma Putty Application on Deck Thinned Down Area near Deck Rail	P-148: Before Non-Skid Coat Application on the Deck Topside (Note Sigma Putty applied area).
08/03/2023 DIR -037 (P-149- P-154)

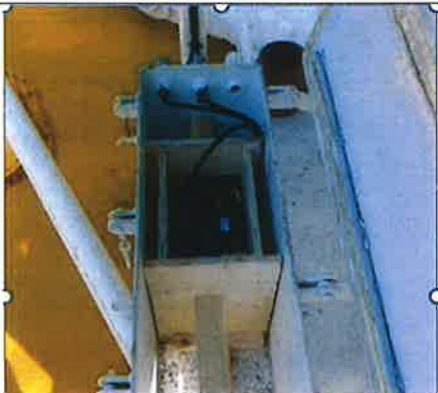
P-149: Solar charging Battery Box.	P-150: Weather-tight Covers used for both Tugger Winch and Battery Box. Good Practice.

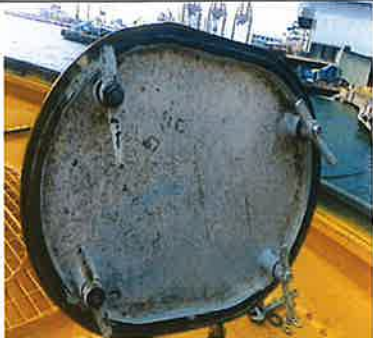
<p>P-153: Inside access cover was not painted. Final Punch listing. Area was painted.</p>	<p>P-154: No Open-Close marking on the Access Door Handles. Final Punch listing. Marked.</p>
