TANK ROOF LAYOUT

CEYLON PETROLEUM CORPORATION
4TH FLOOR, NO. 609,
DR. DANISTER DE SILVA MAWATHA,
COLOMBO 09,
SRI LANKA.

TANK FLOOR THICKNESS SURVEY RESULTS - 2024

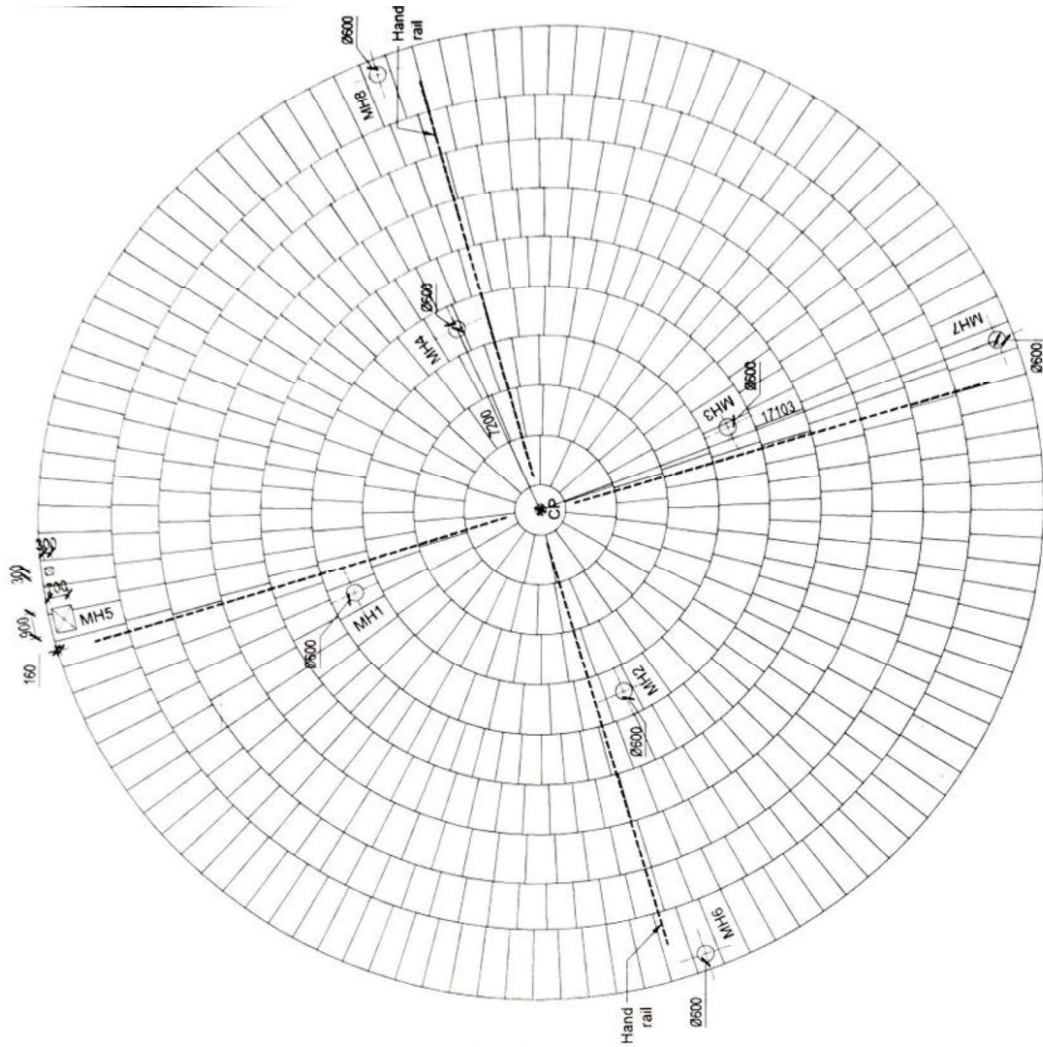
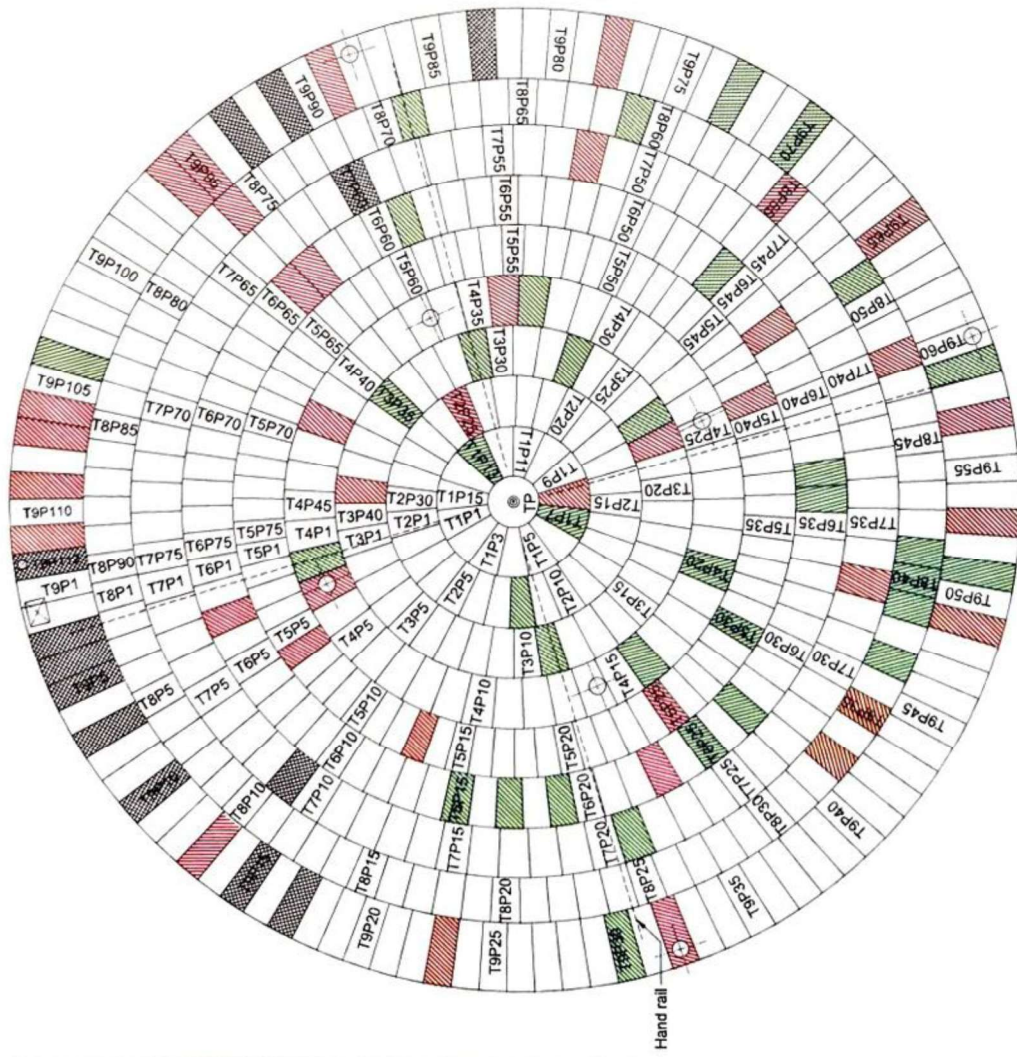
Damaged Roof Plate

Plates of low thickness at each Course

Plates of highest thickness at each Course

Plate thickness of the Roof plates
Drawing No : CPC_TK30_Bottom_I

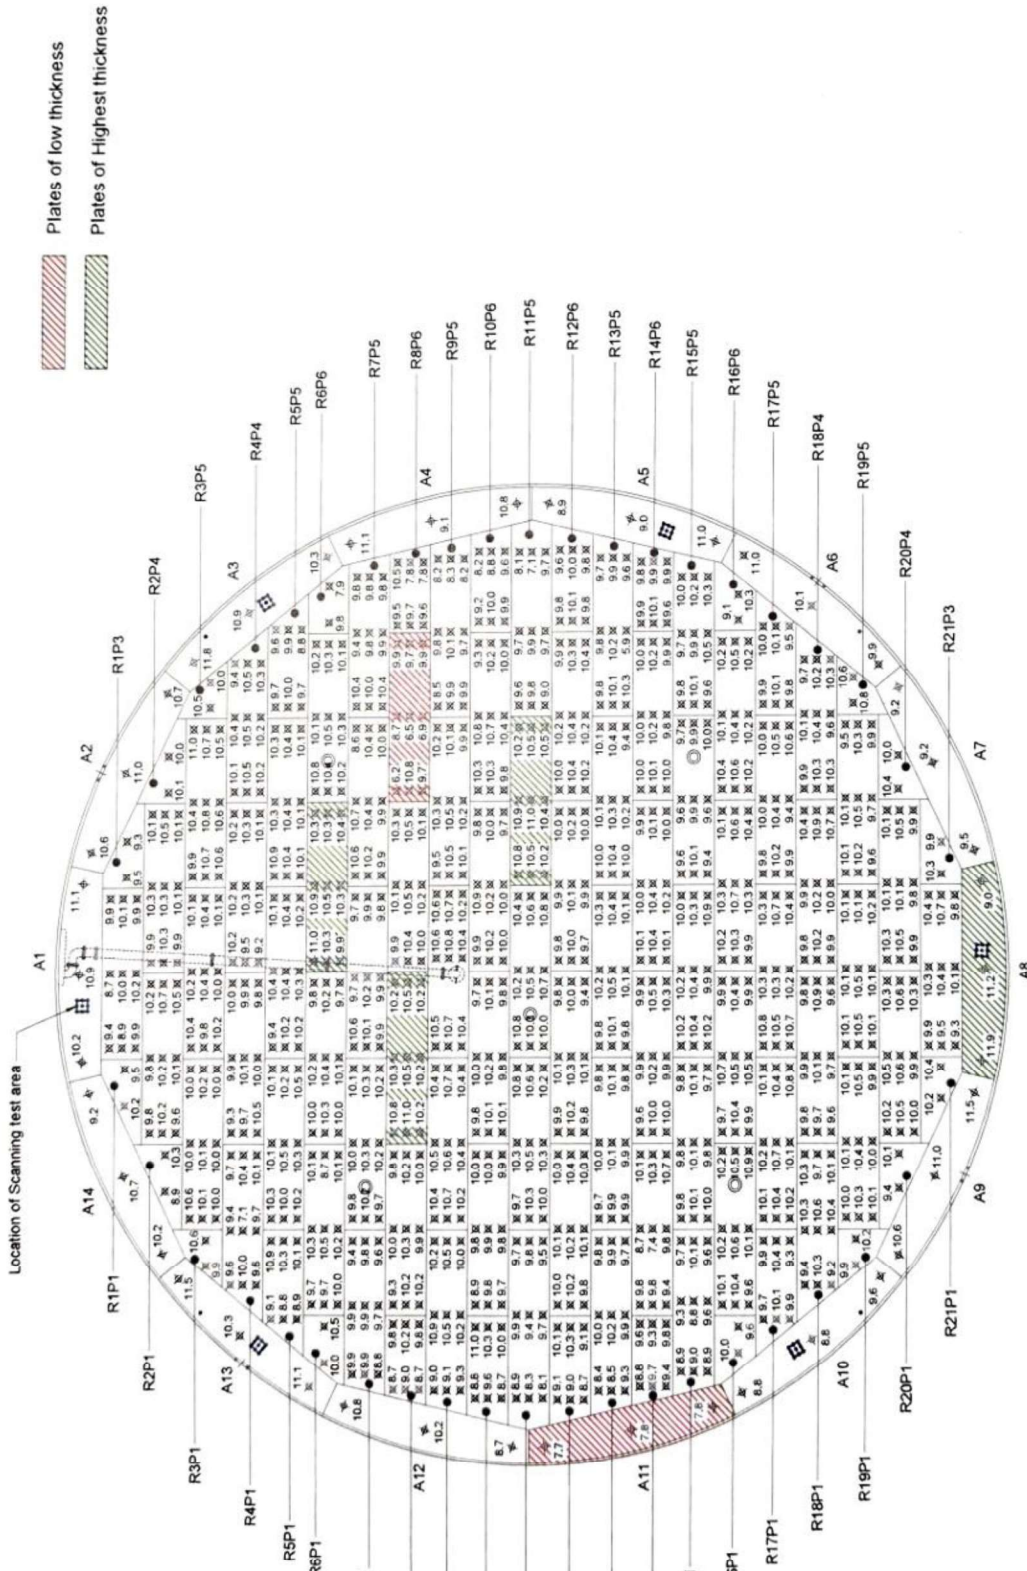
Plate thickness of the Bottom plates
